INDOOR AIR QUALITY ASSESSMENT

**Massachusetts Department of Mental Retardation
Hogan Regional Center, 3 Hathorne Circle
Village of Hathorne, Danvers, Massachusetts**

Prepared by:
Massachusetts Department of Public Health
Center for Environmental Health
Bureau of Environmental Health Assessment
Emergency Response/Indoor Air Quality Program
May 2004

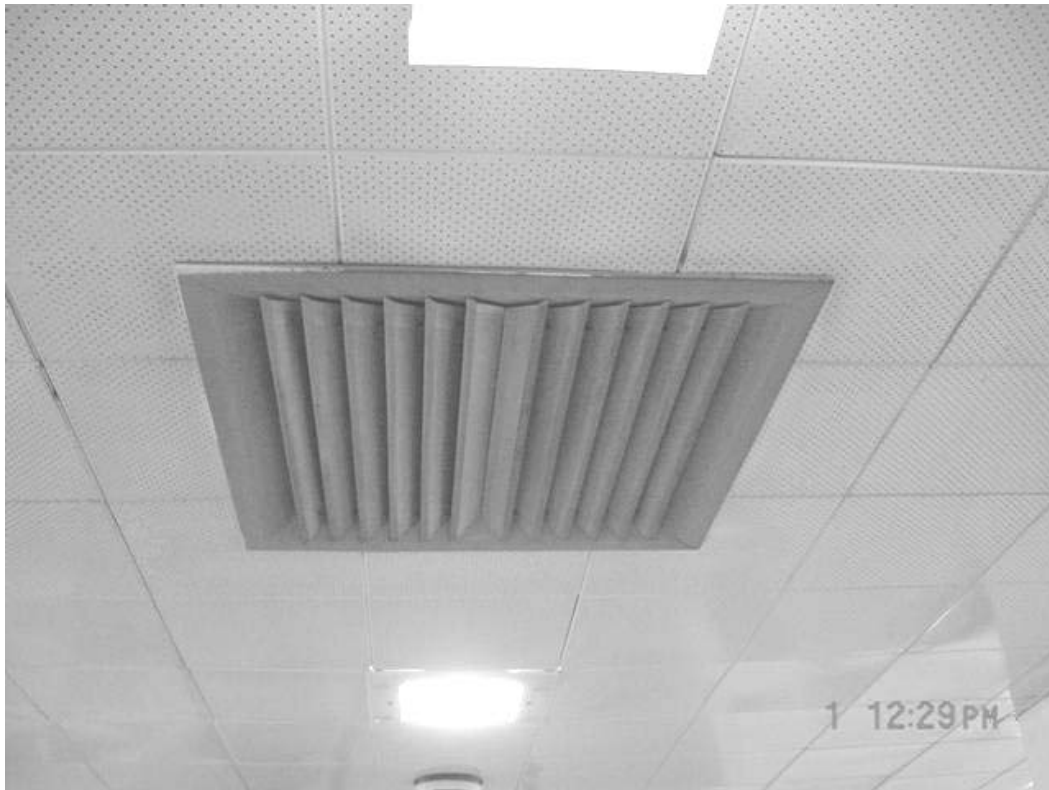
Picture 1

It can be seen from Table 1 that carbon dioxide levels were below 800 parts per million of air (ppm) in all areas surveyed throughout the building, indicating adequate air exchange. Air handling units (AHUs) on each floor provide fresh air. Fresh air is supplied to occupied spaces by ceiling mounted air diffusers (Picture 1), which are connected to AHUs via ductwork. Air is exhausted through ceiling mounted return vents (Picture 2) connected to ductwork. These systems were operating during the assessment.

Ceiling-Mounted Supply Air Diffuser

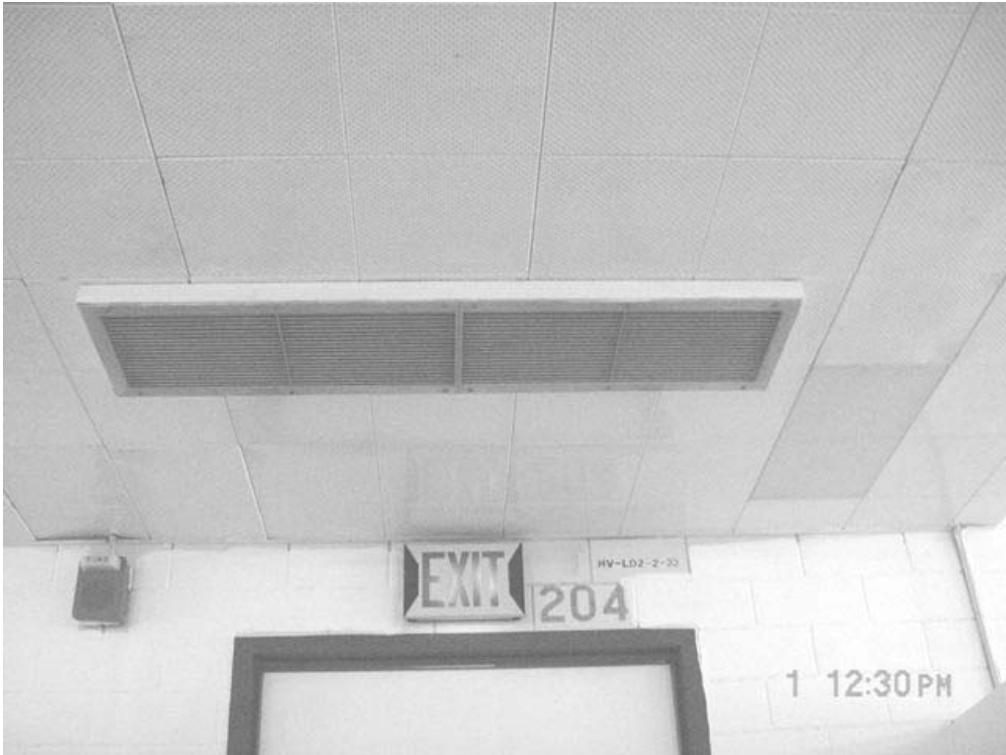
Picture 2

Ceiling-Mounted Return/Exhaust Vent

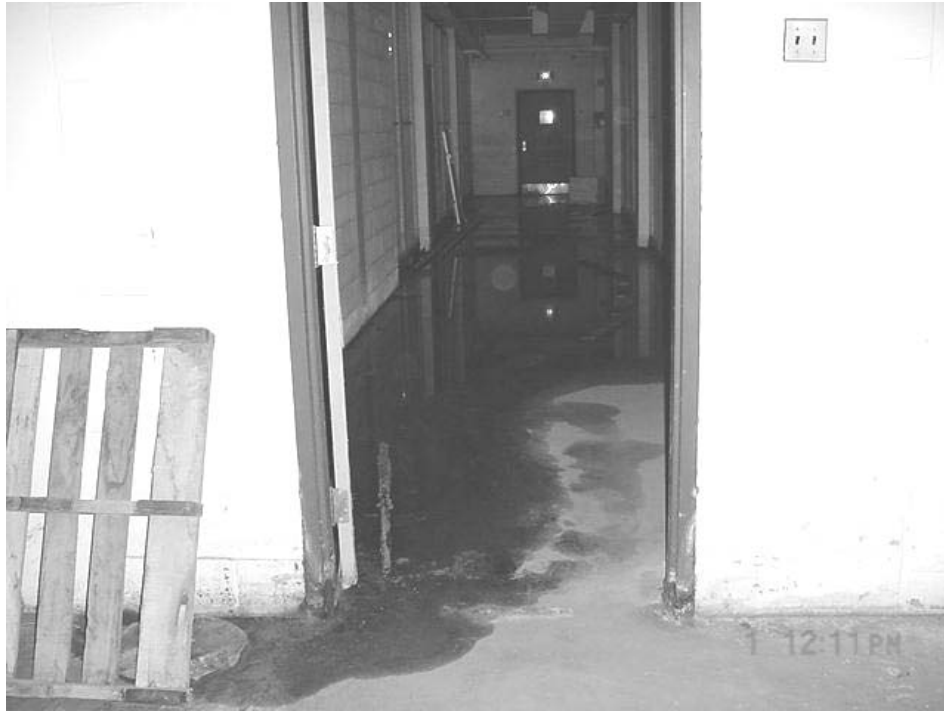
Picture 3

The basement appears prone to repeated flooding. Moisture sources and water-damaged materials were identified in the basement during the assessment. The heavy, driving rain helped to identify moisture sources. BEHA staff observed several inches of standing water in stairwell 1 and in several basement areas (Picture 3). The primary area of water intrusion appeared to be in the bottom corner of stairwell 1 (Picture 4).

Long-View of Water Accumulation in the Basement

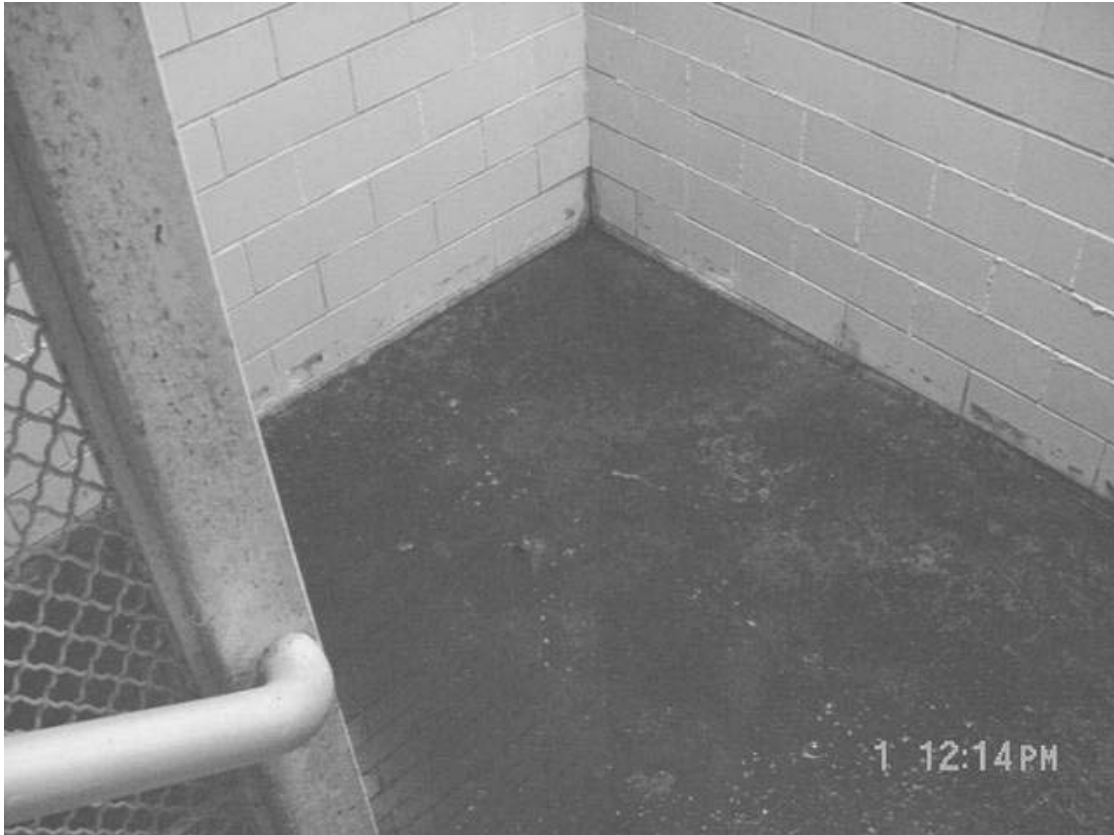
Picture 4

Point of Water Intrusion in Bottom Corner of Stairwell 1

1. Continue with plans to replace roof. Once the roof is repaired, repair/replace water damaged plaster and ceiling tiles in a manner consistent with recommendations in the EPA's "Mold Remediation in Schools and Commercial Buildings" (US EPA, 2001).
2. Consult with an architect and/or general contractor about the integrity of the building envelope, especially in regards to water penetration through walls and the foundation.

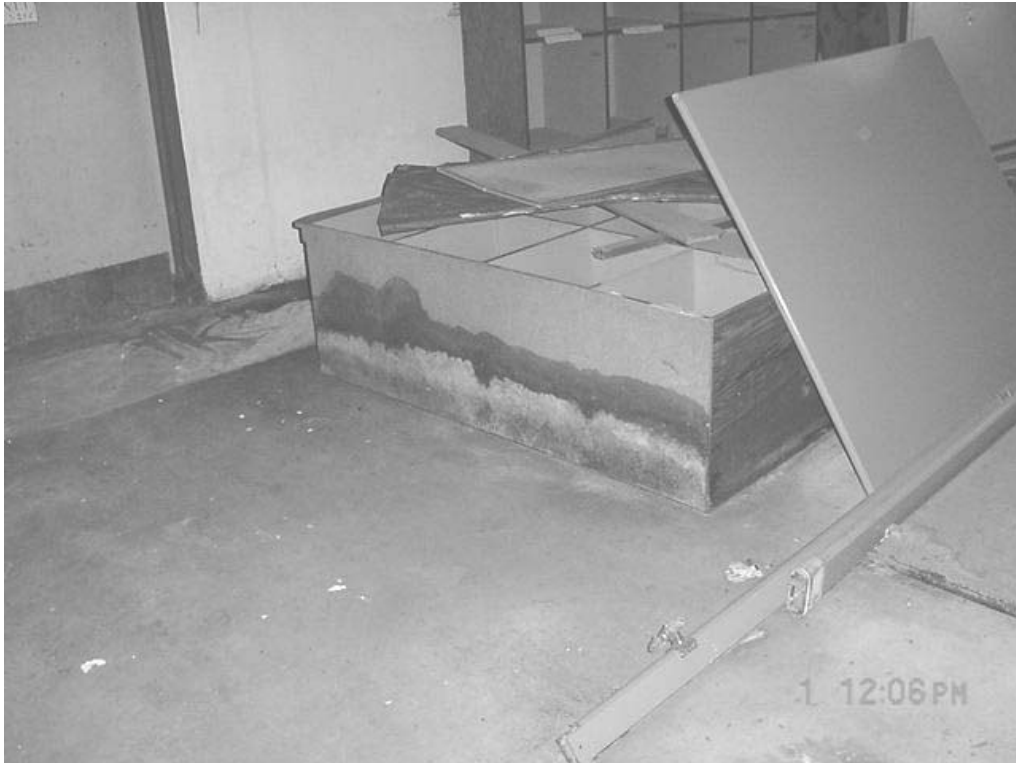
Picture 5

Portions of the basement are used for storage. Because of standing water, some of the stored items were moistened. Porous materials that can support mold growth, such as wooden pallets, pipe insulation, cardboard, paper and shelving appeared to be colonized with mold (Pictures 5-7). The US Environmental Protection Agency and the American Conference of Governmental Industrial Hygienists (ACGIH) recommend that porous materials be dried with fans and heating within 24 to 48 hours of becoming wet (US EPA, 2001; ACGIH, 1989). If porous materials are not dried within this time frame, mold growth may occur. Water-damaged porous materials cannot be adequately cleaned to remove mold growth. The application of a mildewcide to moldy porous materials is not recommended.

Water Damage/Mold Colonized Wooden Shelving in Basement

1. Discard stored materials and building materials that appear to have mold contamination. This measure will remove actively growing mold colonies that may be present. Remove mold contaminated materials in a manner consistent with recommendations in “Mold Remediation in Schools and Commercial Buildings” published by the US Environmental Protection Agency (US EPA, 2001). Copies of this document can be downloaded from the US EPA website at: http://www.epa.gov/iaq/molds/mold_remediation.html. Please note that removal of pipe insulation containing asbestos would be subject to federal and state asbestos removal and disposal laws and regulations.

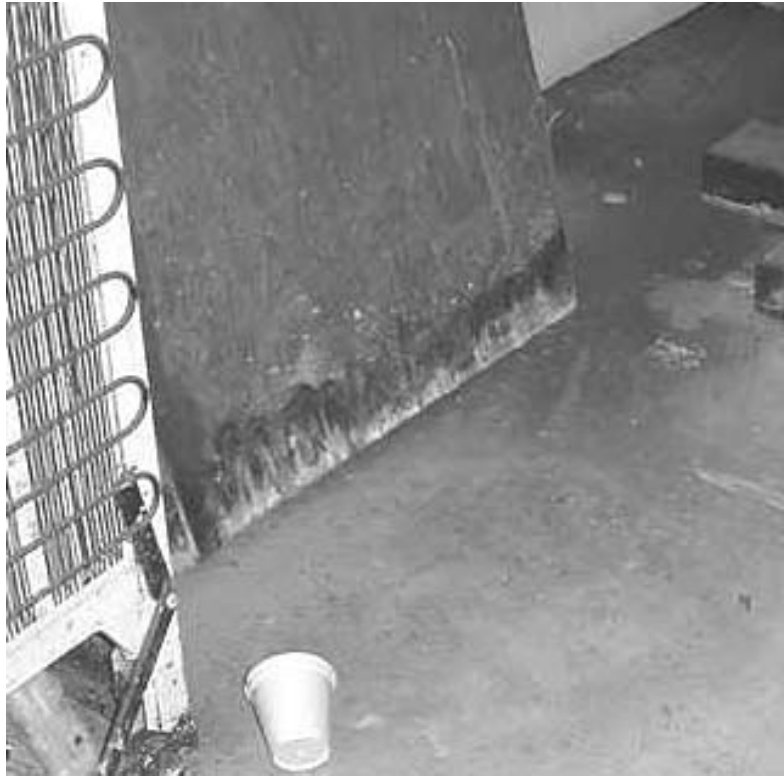
Picture 6

Water Damage/Mold Colonized Wooden Door in Basement

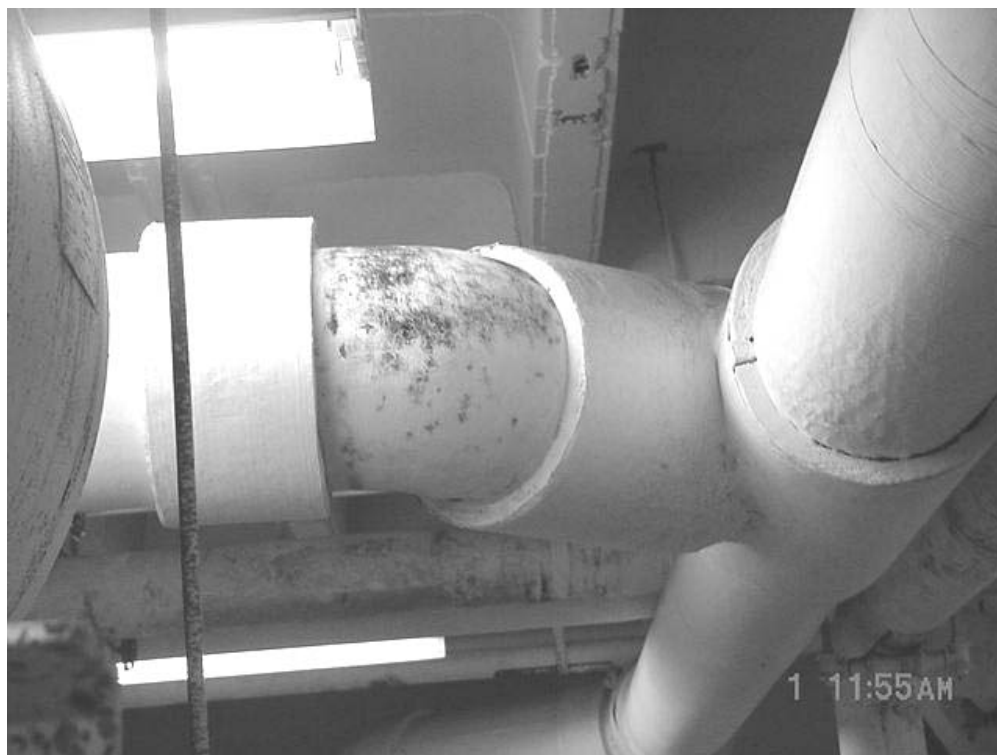
Picture 7

Mold-Colonized Pipe Insulation in Basement

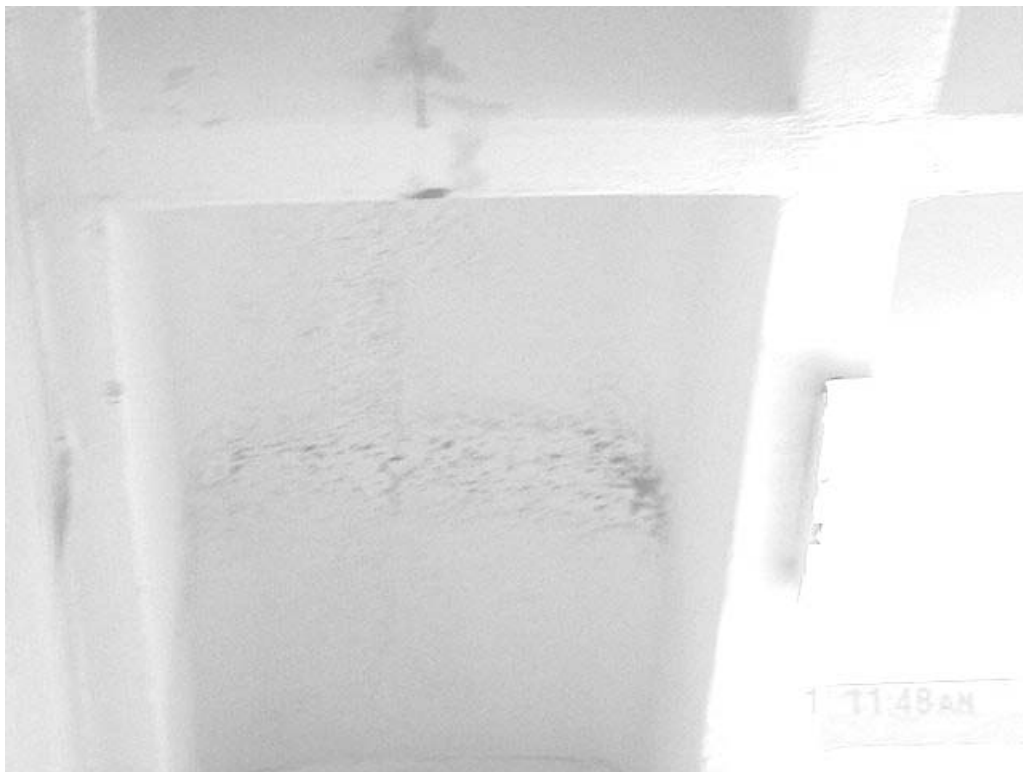
Picture 8

In addition, musty odors and visible mold growth were detected on the ceiling and walls of stairwell 2 (Picture 8). Building materials like cement and concrete are not conducive to mold growth; however, dirt, dust and other debris that accumulate on the surface of these materials can provide a medium for microbial growth, especially if moistened repeatedly (e.g., condensation from extended periods of high relative humidity). BEHA staff recommended that the surface mold in these areas be vacuumed with a high efficiency particulate arrestance (HEPA) filtered vacuum cleaner, followed by disinfection with a one to ten bleach and water solution.

Mold Growth on Surface of Stairwell Ceiling

4. Vacuum surface mold in the stairwell with a (HEPA) filtered vacuum cleaner, followed by disinfection with a one in ten bleach solution.
5. Establish communications between all parties involved with remediation efforts, including building occupants, to prevent potential IAQ problems.

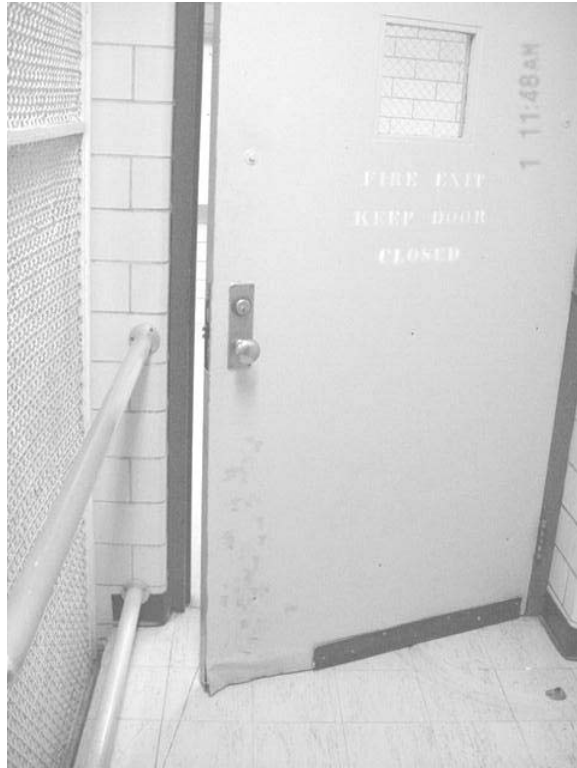
Picture 9

Potential means for the movement of basement/stairwell odors and particulates to occupied areas of the building were also identified. The most obvious pathway is the basement/stairwell doors. Fire doors to the upper floor marked “Keep Closed” were found propped open (Picture 9). Stairwell doors should remain closed to minimize airflow into the main hallway. In addition, the metal doorway at the bottom of stairwell 1 was severely corroded. As a result, spaces exist under the doorframe. These spaces allow odors and particulates to move from the basement to occupied areas. This condition is augmented by a condition known as the stack effect.

Fire Door to Second Floor Found Propped Open

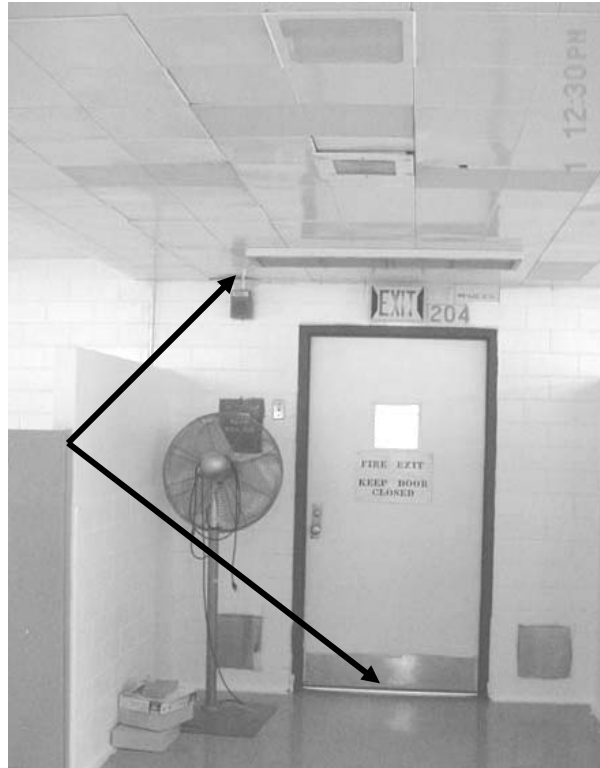
Picture 10

The stack effect is experienced when airflow in buildings rises from lower to upper floors. Stairwells are prone to this condition due to temperature and pressure differentials. As airflow is created, airborne particulate matter and odors can migrate to occupied areas of the building. Exhaust/return vents located near stairwell doors at the ends of the second floor hallway facilitate odor migration (Picture 10). As the return vents draw air, the ends of the hallway become depressurized. As a result, odors from the stairwell are drawn through spaces beneath the stairwell door and into occupied areas. Other potential pathways for particulate/odor migration include utility holes, floor cracks and other penetrations (Picture 11).

Proximity of Return Vent to Stairwell Door, Note Space beneath Door

3. Continue to change filters for air handling equipment as per manufacturer's instructions, or more frequently if needed.
4. Install weather-stripping around and door sweeps beneath stairwell doors to prevent potential odor entrainment.

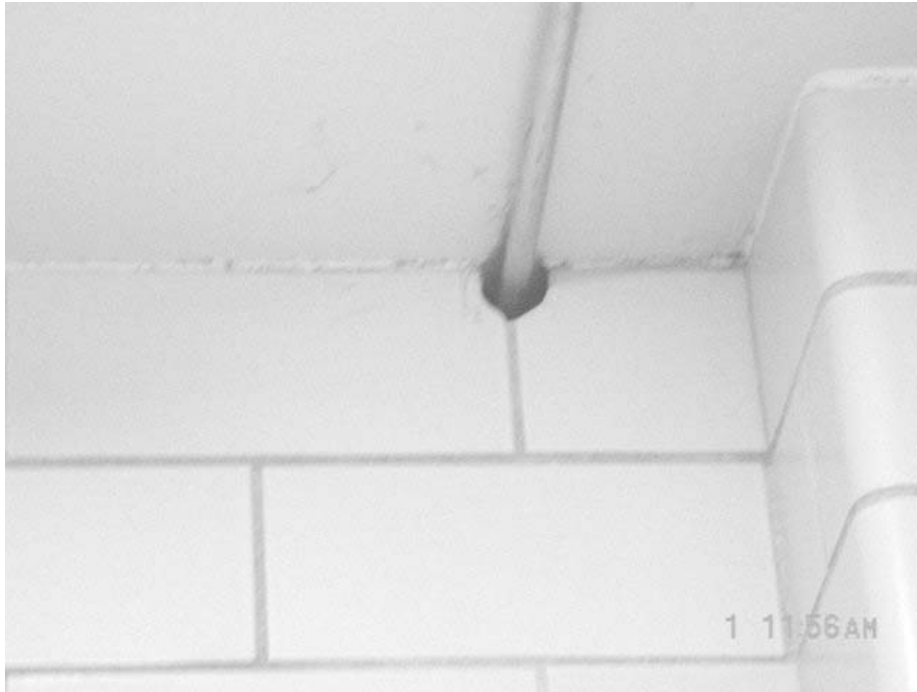
Picture 11

Open Utility Hole in Stairwell/Basement

5. Seal holes in the floors, walls and ceilings for pipes and cables to prevent infiltration of basement pollutants.
6. Refer to resource manuals and other related indoor air quality documents for further building-wide evaluations and advice on maintaining public buildings. These materials are located on the MDPH's website at <http://www.state.ma.us/dph/beha/iaq/iaqhome.htm>.

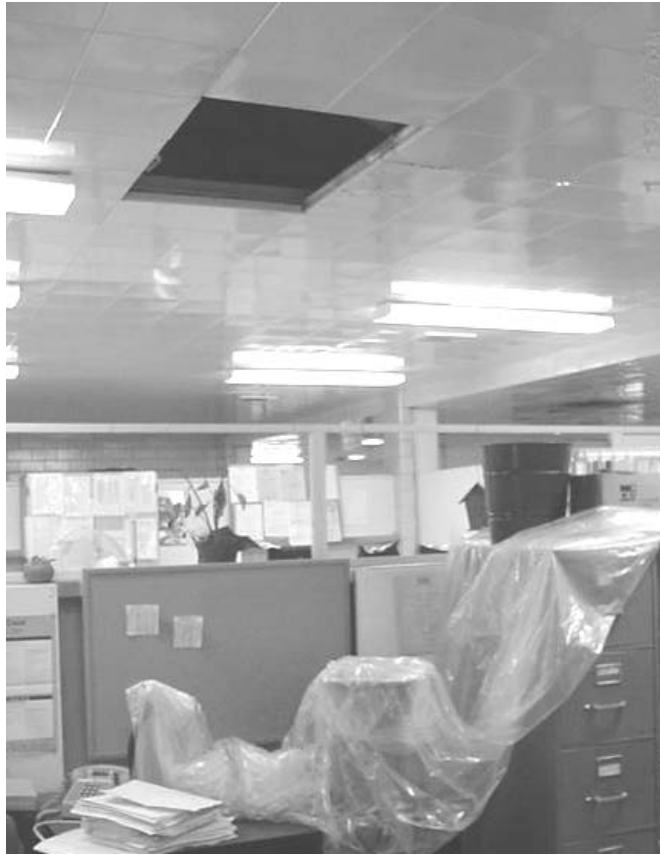
Picture 12

The HRC also has a history of chronic roof leaks. A number of areas on the second floor showed signs of water damage. Stained walls, corroded metal ceiling panels, peeling paint and efflorescence were noted (Pictures 12-14). Efflorescence is a characteristic sign of water damage to building materials, but it is not mold growth. As moisture penetrates and works its way through building materials (e.g., plaster), water-soluble compounds dissolve, creating a solution. As this solution moves to the surface, the water evaporates, leaving behind white, powdery mineral deposits. MDR officials reported that funding for roof repair is part of a planned capital repair project.

Active Roof Leak on Second Floor, Note Missing Tiles and Plastic Covering Items

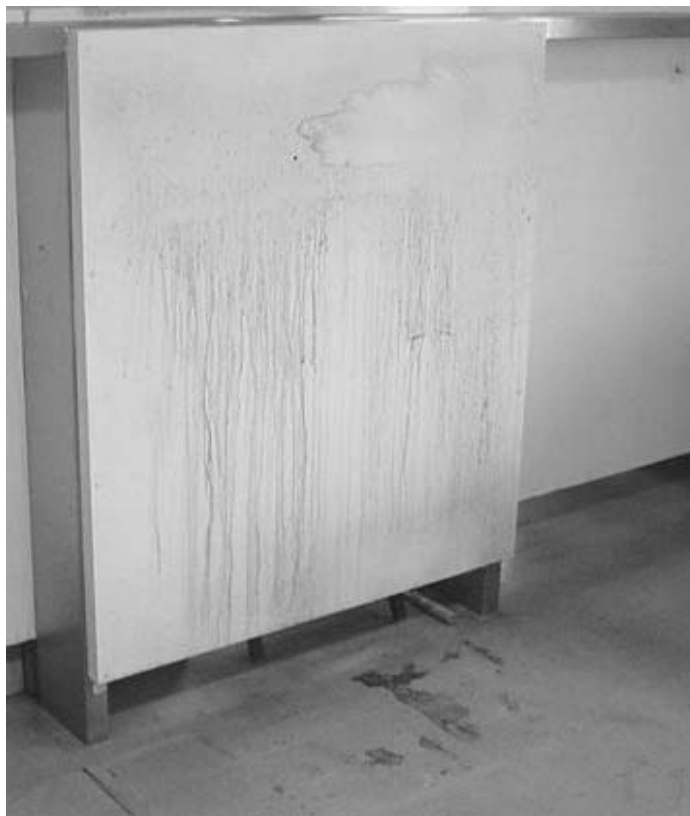
Picture 13

Water Stained Office Material on Second Floor

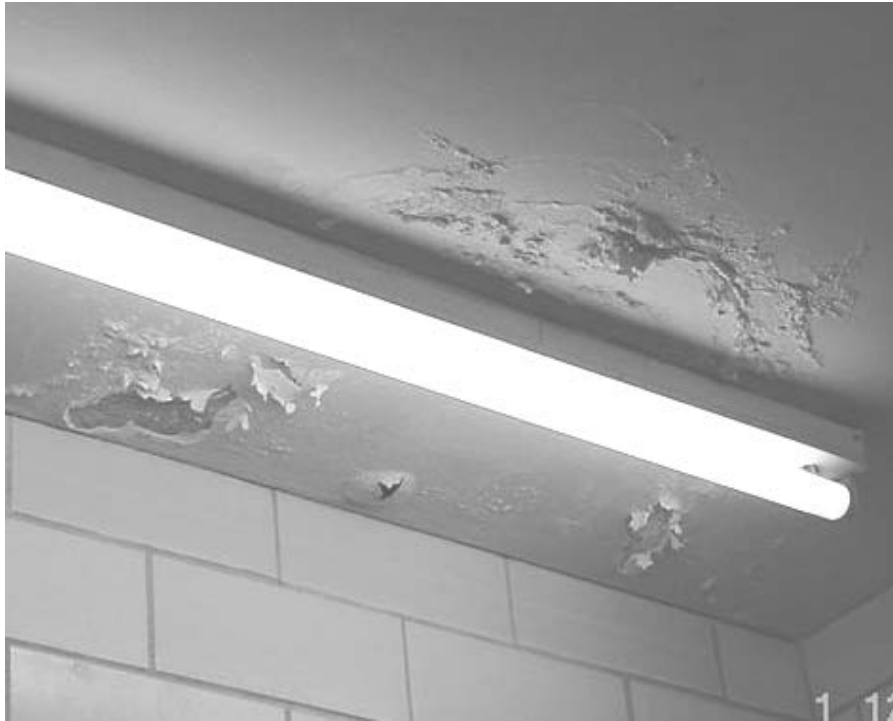
Picture 14

Peeling Paint and Efflorescence in Second Floor Storeroom
